Riveting Thin A320 Stacks

Peter Zieve and John Fenty
Electroimpact, Inc.

Osman Emre Çelek
TAI - Turkish Aerospace Industries, Inc.

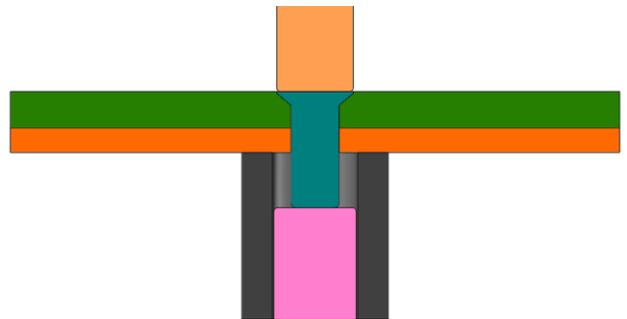
The normal way to install a skin flush rivet is shown schematically in Figure 2. The lower clamp presses the material to be riveted up against the rivet head. The lower clamp is the tubular portion of the riveting anvil shown in Figure 3. A photograph of the range of lower anvil tooling is shown in Figure 4. For the thinnest stacks, where the panel skin is under 2mm (2024) and the stringer is under 2mm (7075) the normal process of riveting will cause deformation of the panel or dimpling.

Figure 2. Schematic of normal rivet installation

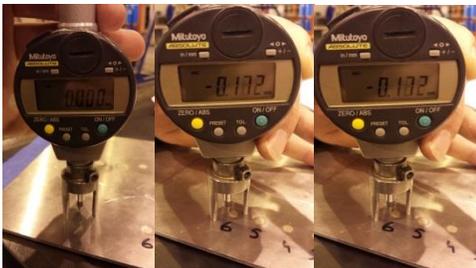
Figure 6 shows the measurement of the problem which occurs for stacks of 4mm and less. Thin stacks readily bend out of plane. The flushness spec of the rivet is 0 to +0.127mm and in Figure 6 you can see that the head height goes negative due to dimpling and is therefore out of spec.

Figure 6. Measurements showing dimpling in stacks thinner than 4mm.

We found a solution by forming the rivet with the upper pressure foot extended. The upper pressure foot is shown in Figure 8. In the photograph the observer is looking up from the bottom. The upper clamp foot is driven up and down by four Compact Automation custom cylinders with square body. They are 2.5" bore and 0.5" stroke. The upper anvil and fingers can be seen above two of the four clamp cylinders in Figure 9.

We determined that the effect of the uneven rivet interference could be ironed out by forming the rivet with the clamp nose extended and with the upper anvil face slightly behind the clamp nose. We form the rivet with the upper anvil slightly retracted. See the label "DISTANCE BACK FROM PANEL" in Figure 10.

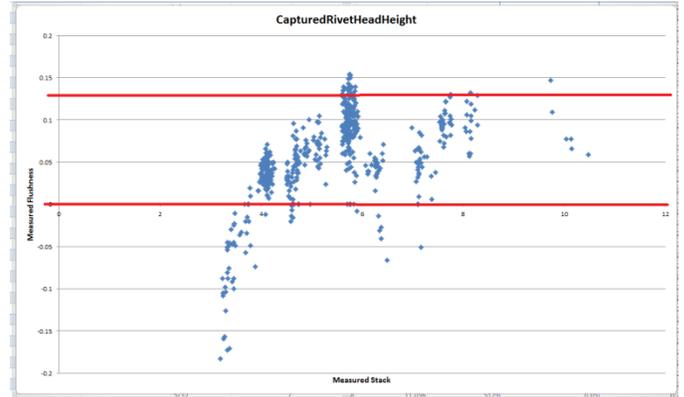
Figure 7 is production data taken from the data collection system (DCS) on the E7000 machine before the fix proposed here was implemented. The stack measurement is measured with a precision Heidenhain pencil encoder built into the lower pedestal. The rivet flushness is measured each cycle by a Keyence LK-H157 laser micrometer mounted on the transfer plate. As stacks go under 4mm the dimpling becomes severe.

Figure 7. DCS on E7000 showing production data before proposed fix

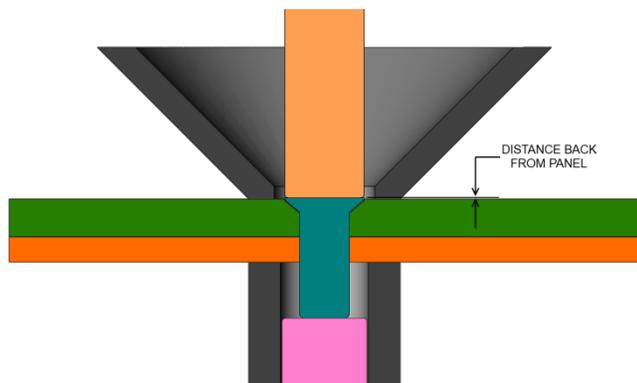
Figure 10. Upper anvil slightly retracted and DISTANCE BACK FROM PANEL..

Table 1 shows the results of varying the DISTANCE BACK FROM PANEL. An optimum was found at 0.3mm. At that dimension the dimpling effect for the panel adjacent to the rivet is eliminated. At 0.3mm the flushness measurement of the rivet head is .06mm which is exactly in the middle of the flushness tolerance. The machine is running in this mode for grips 5.5 and 6 only. The specification for measured tail height is 1.6mm to 2.4mm so all of the table entries are within specification.”

We asked the customer to check gaps under the rivet heads. This is a potential risk for switching from the method in Figure 2 to the method in Figure 10. For the DISTANCE BACK FROM PANEL dimension of 0.3mm no gaps under rivet heads were found. The methodology is approved and is now used in production.
