## Sharklet Brings New Technology to Electroimpact E4000 LVER Machine

2012-01-1853

Carter L. Boad and Paul Haworth  
Electroimpact Inc.

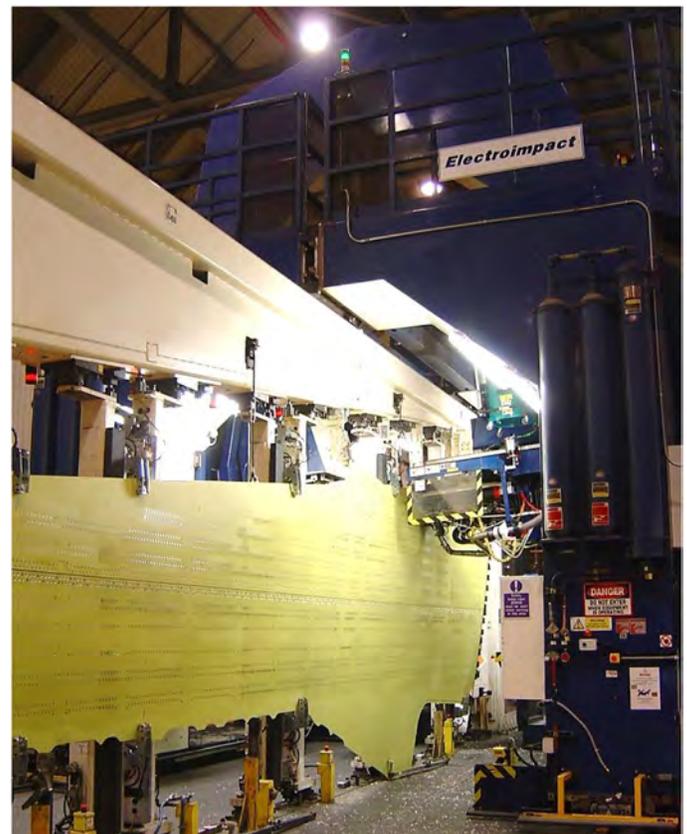
*Figure 1. E4000 (SA1) machine working on an A321S panel*

Although the HSRM and SA2 machine cells would be modified to accommodate the new wings, Airbus saw this as an opportunity to not only modify the SA1 machine for Sharklet, but to upgrade the aging machine so it could continue to produce wing panels for the next 15 years. The modifications were extensive and included a new CNC, new motors, scales, and spindles as well as new technologies such as laser tracers and normality sensors. After the modifications were complete, the SA1 machine re-entered production effectively as a new machine, but without the slow ramp-up, schedule risks, and teething problems of a brand new machine (see [Figure 1](#)).

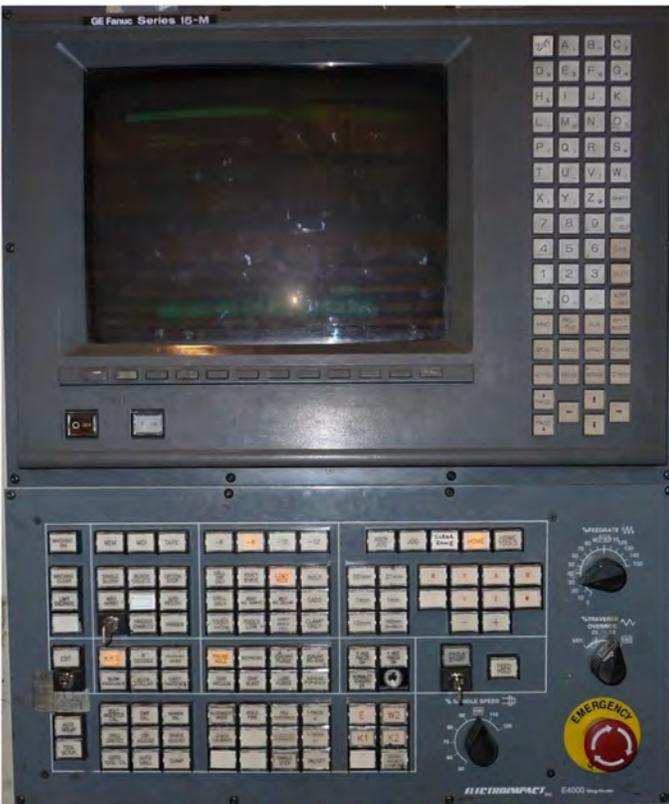
**Figure 2. 15-M based operator interface**

In addition to enhancements in servo control, the newer 30i control also offered opportunities to greatly improve the size, clarity and functionality of the machine HMI. The older control used a 10" CRT display running a text based HMI. The new control uses a 15" LCD touch screen display

running a full colour text/graphical user interface. The original 15 series based HMI can be seen in [Figure 2](#), and the updated interface in [Figure 3](#).

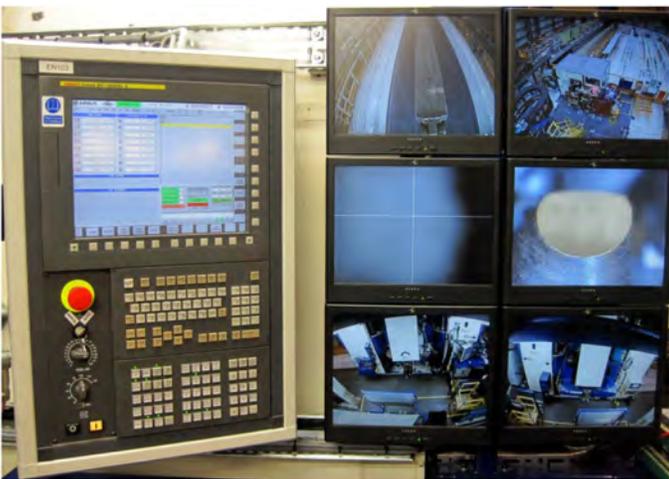
**Figure 3. 30i based operator interface**

Using the FANUC custom HMI designer, Fanuc Picture, Electroimpact was able to offer a custom machine interface that dramatically improved the end user experience. A new suite of maintenance screens added to the HMI have also helped to reduce MTTR by improving the quality of maintenance information available to technicians that attend machine breakdowns.

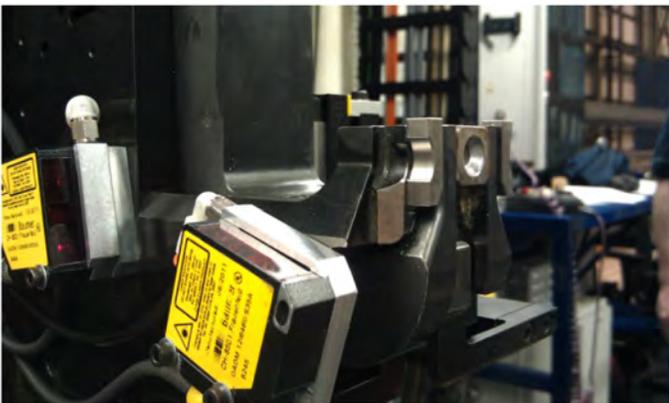
*Figure 5. Laser tracer assemblies*

Tracers contact the wing while the machine is moving, measuring the distance between the machine and the part. By their nature, mechanical sensors are susceptible to crashes with parts and fasteners. These crashes lead to machine down-time. Electroimpact evaluated a number of non-contact laser sensor candidates and settled on Baumer OADM12I6460/S35A laser distance measuring sensors. These have an accuracy tolerance of  $\pm 1.3$  mm over a range

of 40 mm enabling us to meet the positional and rotational accuracies in the machine specification without touching the part. Figure 5 shows the stringer side rivet tooling with Baumer laser Y (foreground) and V (background) laser tracers.

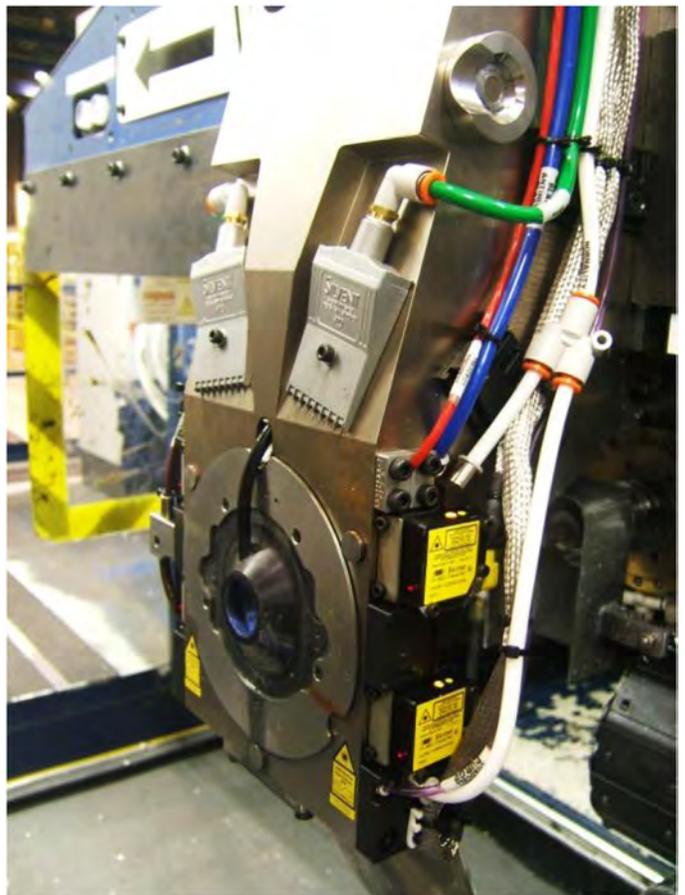
*Figure 6. Headstone with laser normality sensors*

In addition to the new spindles, the skin side of the machine was further upgraded with a new headstone assembly. This new assembly featured an integrated load cell, laser normality sensors, and a revised process camera. The legacy machine measured clamp force using a load cell attached to the ball-screw assembly. By moving the loadcell to the headstone, just behind the clamp pad, the accuracy and response time was greatly improved. We expected a clamp cycle time reduction of at least 100ms through the use of this new loadcell. [Figure 6](#) shows the new headstone assembly.

Like the mechanical tracers on the stringer side tools, the old headstone used mechanical normality sensors on the skin side. Although functionally sound, they were one of the top five causes of breakdowns on the machine, mostly due to the sensors being constantly knocked off the headstone or damaged as they were accidentally and repeatedly run into holes, dowels, slave bolts, fixture clamps, etc. The same Baumer OADM1216460/S35A laser sensors were chosen to replace the old normality sensors. These compact sensors could be permanently mounted to the side of the headstone and their low profile meant better protection from potential damage.

The old headstone had an integrated camera that provided a view of the process but it was not very effective and was difficult to set up and keep working properly. The new camera was based on the SA2 design and repositioned lower in the headstone to provide the operator a much better view of the drilling and riveting process. The new camera is also easier to set-up and requires minimal maintenance.
